THE ORIGINAL COLOUR FINISH OF THE GOLDEN ROOM

Margriet van Eikema Hommes, Katrien Keune, Ruth Jongsma, Mariël Polman, Carol Pottasch

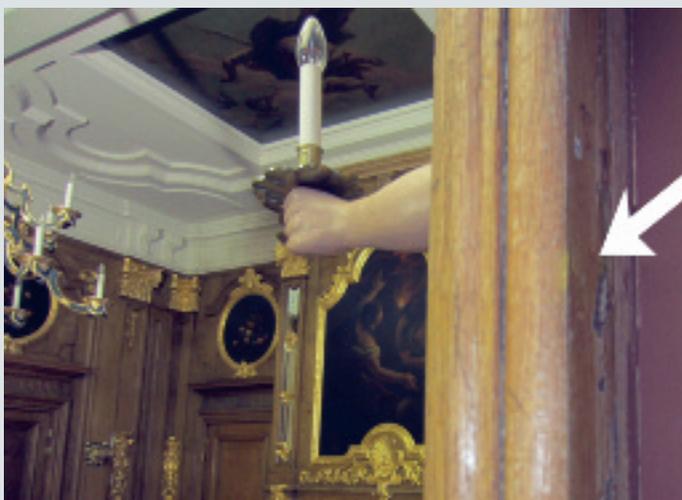
157 The inside of the right-hand shutter box of the middle window. A narrow strip (see arrow) that was never stripped contains all the paint layers. This strip now displays an imitation oak finish, but earlier colour finishes are visible where the paint has flaked off. The rest of the shutter box was covered with sheet material during the 1984-1987 restoration of the Mauritshuis.

During the recent restoration, however, numerous small patches of old paint layers were discovered on the oak walls. Another piece of great good fortune was the fact that the inside of the shutter boxes had never been stripped of their paint. These now display modern imitation oak that is in keeping with the stripped walls, but they had been painted along with the wall panelling time and again since the rebuilding of the ground-floor salon, with the result that all those paint layers are preserved in these boxes (fig. 157). The gilded mouldings surrounding the

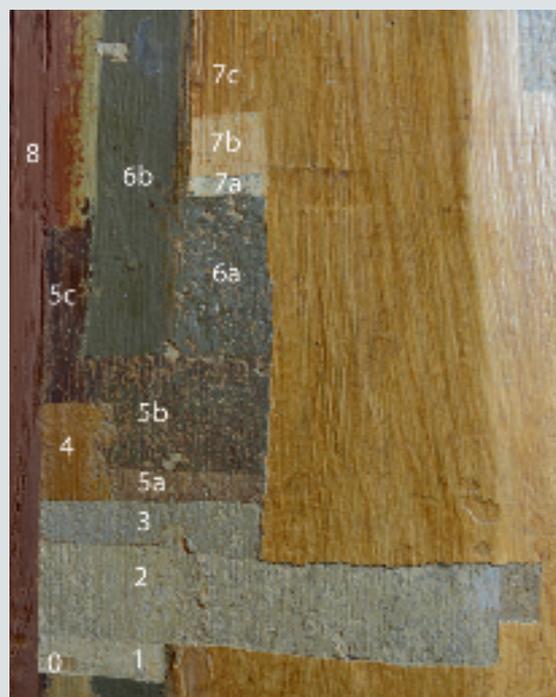
158 A 'colour ladder' of the inside of the right-hand shutter box of the window on the left shows the various stages of finish, which can be seen in the cross-section (figs. 159-160).

- 8: red-brown modern paint attuned to the colour of the sheet material used to cover the side of the shutter box
- 7c: present imitation oak finish (layer 14 in the cross-section)

- 7b: light-coloured base layer of the present imitation oak finish (layer 13)
- 7a: white preparation layer of the present imitation oak finish (layer 12)

- 6b: moss-green finish of 1927 (layer 10 or 11). A section where later paint layers have flaked off
- 6a: moss-green finish of 1927 (layer 10 or 11). A section exposed in the 'colour ladder'

- 5c: dark wood finish (layer 9). A section where later paint layers have flaked off. The imitation wood grain is clearly visible here.
- 5b: dark wood finish (layer 9). A section exposed in the 'colour ladder'

- 5a: light brown base layer of the dark wood finish (layer 8)
- 4: warm yellow finish, dating from the mid-nineteenth century at the earliest (layer 6)

- 3: cool grey finish, possibly dating from 1809-1810 (layers 3 and 4)
- 2: light grey finish of 1713 (layer 1)
- 1: chalk ground layer of the light grey finish of 1713 (missing in the cross-section)

- 0: wood

- 7: greyish preparation layer, and on top of it the red base layer of the present gilding (layers 19 and 20 in the cross-section)
- 6: dark brown finish (layer 12 in the cross-section). This is part of the dark imitation wood finish on the walls. This capital, however, bears no markings of wood grain, such as those seen in the shutter box (see fig. 158, marking 5c).

- 5: brown-yellow finish, which is part of the warm yellow, zinc-containing finish applied in the mid-nineteenth century at the earliest (layers 9 and 10 in the cross-section). The colour here is darker and cooler than the warm yellow in the shutter box (see fig. 158, marking 4). It was possibly intended as a colour accent.

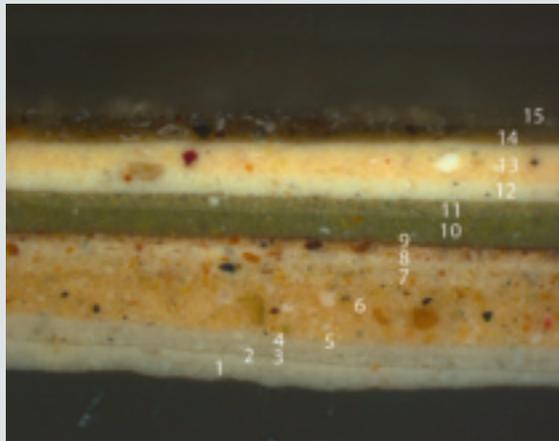
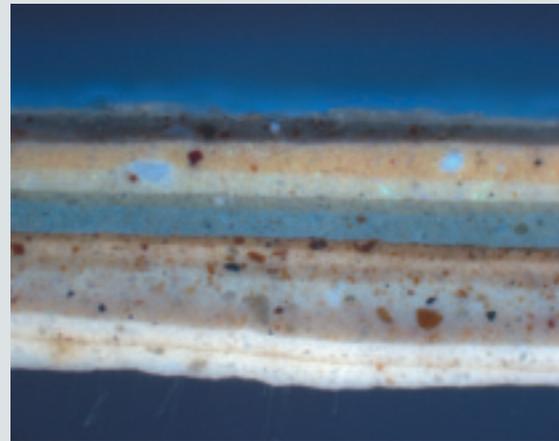
159-160 Paint cross-section from the inside of the shutter box, microscopically enlarged 200x. To the left: normal light; to the right: UV light. Layers 1 and 2 belong to the earliest colour finish of 1713.

- 15: layer of wax
- 14: transparent brown paint layer: top layer of the present imitation oak finish
- 13: salmon-coloured paint layer: base colour layer of the present imitation oak finish

- 12: whitish layer: preparation layer of the present imitation oak finish
- 11: moss-green paint layer rich in binding medium, of 1927
- 10: warm moss-green paint layer, of 1927

- 9: dark brown, transparent paint layer: top layer of dark imitation wood
- 8: light brown paint layer: base colour layer of dark imitation wood
- 7: very light brown paint layer: base layer of dark imitation wood

- ♦ green-yellow paint layer containing zinc white, mid-nineteenth century at the earliest. This layer is missing in this cross-section
- 6: orange-yellow paint layer containing zinc white, mid-nineteenth century at the earliest

- 5: local, very thin lead crust
- 4: grey paint layer, possible dating from 1809-1810: lead white, chalk, fine black pigment, very little brown earth
- 3: grey paint layer, possibly dating from 1809-1810: lead white, chalk, fine black pigment, very little brown earth

- 2: lead crust
- 1: light grey paint layer of 1713: lead white, chalk, a bit of fine black pigment, a few fine particles of red and brown earth
- ♦ chalk layer of 1713, missing in this cross-section

- ♦ wood, missing in this cross-section

Cross-sections show, on top of the earliest colour finish of the walls, a thick build-up of later paint layers (figs. 159-160). To begin with, there are two layers of grey paint that consist of exactly the same pigments: lead white, chalk, fine black pigment and a bit of brown earth pigment. These two layers no doubt belong to the same finish. The 'colour ladder' in the shutter box shows the cool grey (tending slightly towards lilac) of the second finish, which is also somewhat more intense and darker than the first. There is no documentation to tell us when the cool grey layer was applied, but it perhaps dates from 1809 or 1810, when the Mauritshuis underwent far-reaching alterations in order to accommodate the National Library (see p. 148). On top of this cool grey are two yellowish layers containing zinc white, a pigment not produced on a large scale until 1844, indicating that these layers date from the mid-nineteenth century at the earliest. Together these layers formed a warm yellow finish. They were followed by two layers of brown – the lowest layer an opaque light brown and the top layer a transparent dark brown – which combine to form dark brown imitation wood, as can be seen in the shutter box. These layers must have been removed from the walls in or before 1890, since the records tell us that the oak panelling was waxed that year.¹¹ The next paint layer – this time a moss-green colour – was applied in 1927. The moss green was removed in 1951, but remained in the shutter box, where it was covered by the imitation oak finish that is now visible.

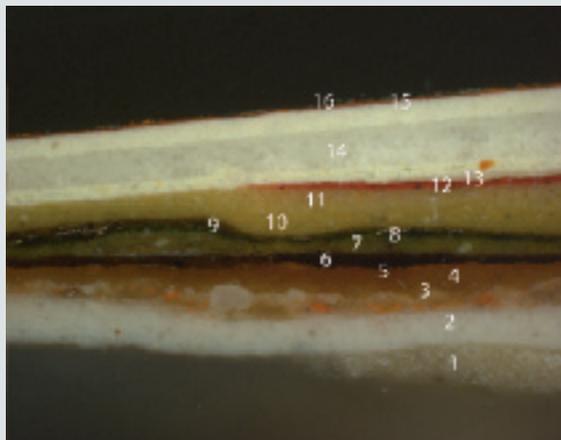
161 Cross-section from the moulding surrounding the mantelpiece of the fireplace on the right when entering the salon, microscopically enlarged 200x, normal light. Layers 1 to 5 are part of the earliest gold-leaf finish.

- 16 gold leaf, from the 1984-1987 phase
- 15: orange-pink base layer for the gold leaf applied in the 1984-1987 phase: red earth in alkyd resin
- 14: several whitish preparation layers from the 1984-1987 phase

- 13: gold leaf, dating from 1951
- 12: red-earth base layer for the gold leaf applied in 1951
- 11: pale yellow-green layer, applied after 1942
- 10: pale yellow-green layer, applied after 1942

- 9: organic layer
- 8: layer rich in binding medium, with copper shavings
- 7: warm moss-green paint layer applied in 1927
- 6: transparent layer rich in binding medium, with strong fluorescence in UV light, containing a little bit of dark brown and red earth

- 5: gold leaf
- 4: yellowish layer, mixture for gold leaf: yellow earth and very little brown and red earth
- 3: orange but originally whitish layer: lead white (largely converted into red lead), chalk, very little black pigment

- 2: light grey paint layer of 1713: lead white, chalk, a bit of fine black pigment, a few fine particles of red and brown earth
- 1: chalk ground, dating from 1713

- ♦ wood missing in the cross-section

The original gilding on the grisaille,²⁷ *tondo* and mantelpiece mouldings, as well as on part of the carving on the chimney breast remained visible for a long time (fig. 161). At some point it was decided, however, to tone down the remaining gold leaf, since it was covered with a paint/substance – very rich in binding medium and probably semi-transparent for that reason – which was coloured with brown earth. In 1927, the gold leaf was covered with moss-green paint.²⁸ A thin layer of copper or copper paint was applied to the mouldings, on top of the moss green.²⁹ A watercolour of 1942 therefore shows these elements in yellow (p. 135,

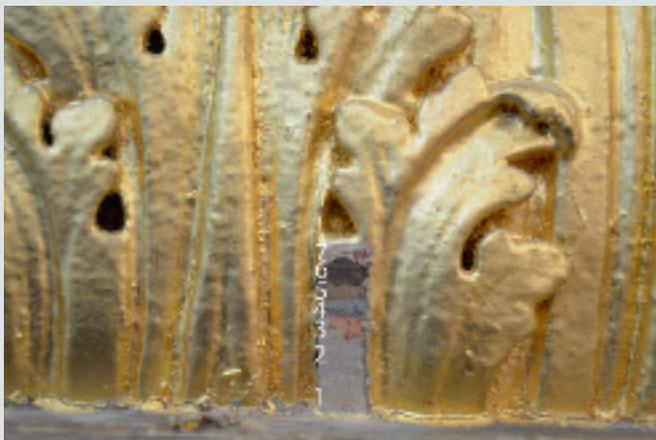
162 This detail of a capital on the window wall shows the inferior quality of the present gilding, with a poorly prepared, bumpy surface and even a hair of the brush. A 'colour ladder' shows a few (but by no means all) previous stages of finish. These stages can be seen in the cross-section of the capital (fig. 163).

- 4: grey paint layer possibly dating from 1809-1810 (layers 6 and 7 in the cross-section), with the copper (which has turned brown) and the brown layer of binding medium applied over the copper (layers 4 and 5 in the cross-section) shining through

- 3: orange but presumably originally whitish layer, over which the mixtion and the copper leaf were applied (layer 2 in the cross-section)
- 2: light grey paint layer, dating from 1713 (layer 1 in the cross-section)

- 1: chalk ground, dating from 1713 (not present in the cross-section)

The mouldings around the paintings and some of the carvings on the walls were decorated with gold leaf on top of this light grey.¹³ Its application was probably not included in the above-mentioned sixty-guilder paint job of 1713, since gold leaf would have cost far more than that.¹⁴ Cross-sections show how the gold finish was achieved (fig. 161). On top of the light grey paint layer is a paint layer mixed with lead white, chalk and a bit of fine black pigment. The lead white in this layer was converted through a chemical reaction with the oil medium via lead soaps into red lead, which caused this layer to turn bright orange.¹⁵ On top of this is an oil-rich layer consisting mainly of yellow earth, a so-called mixtion that formed the base layer, over which the gold leaf was applied.¹⁶ The wafer-thin sheets of gold were cautiously affixed to the not-quite-dry mixtion. A mixtion gilding or oil gilding has a slightly dull appearance, which is why it was called 'matte gold'.¹⁷ The present gilding, which was applied to a base layer of red earth and alkyd resin, also has a matte appearance,¹⁸ although the original gilding must have been considerably more subtle. The present gold leaf was applied to a thick build-up of later paint layers, which greatly reduced the sharpness of the carving and also resulted in a very irregular ground layer that badly mars the present gilding (fig. 162).

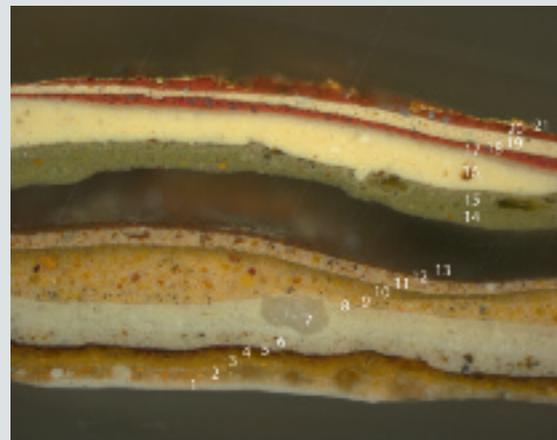
163 Cross-section taken from a capital on the window wall, next to the 'colour ladder', microscopically enlarged 100x, normal light. Layers 1 to 5 are part of the earliest colour finish with copper.

- 21: gold leaf, dating from the 1984-1987 phase
- 20: orange-pink base layer for the gold leaf applied in the 1984-1987 phase: red earth in alkyd resin

- 19: whitish preparation layer, dating from the 1984-1987 phase
- 18: gold leaf applied in 1951
- 17: red-earth base layer for the gold leaf applied in 1951

- 16: whitish layer, dating from 1951
- 15: cool moss-green paint rich in binding medium, dating from 1927
- 14: warm moss-green paint layer, dating from 1927

- 13: organic layer: wax? The paint sample is split above this layer.
- 12: transparent dark brown paint layer: top layer of dark brown imitation wood
- 11: light brown paint layer: base colour layer for dark brown imitation wood

- 10: green-yellow paint layer containing zinc white, mid-nineteenth century at the earliest
- 9: orange-yellow layer containing zinc white, mid-nineteenth century at the earliest

- 8: lead crust
- 7: grey paint layer, possibly dating from 1809-1810: lead white, chalk, fine black pigment, very little brown earth
- 6: grey layer with coarser pigments, possibly dating from 1809-1810: lead white, chalk, fine black, very little brown earth

- 5: dark copper-containing organic layer
- 4: copper leaf: present only locally, partly obliterated by chemical reaction
- 3: yellowish layer, mixtion used as a base for the copper leaf: yellow earth and very little brown and red earth

- 2: orange but presumably originally whitish layer: lead white (largely converted to red lead), chalk, very little fine black
- 1: light grey layer: lead white, chalk, a bit of fine black pigment, a few fine particles of red and yellow earth

- ♦ chalk ground, missing in the cross-section
- ♦ wood, missing in the cross-section

Gold was found on the mouldings surrounding the *tondi* and the *grisailles*, the mouldings of the mantelpieces and their accompanying carvings, and the decorations on the pilasters.¹⁹ The capitals, on the other hand, appear originally to have been finished with pure copper and must therefore have had a red glow (fig. 163). The large carved decoration above the main entrance door, which has now been completely

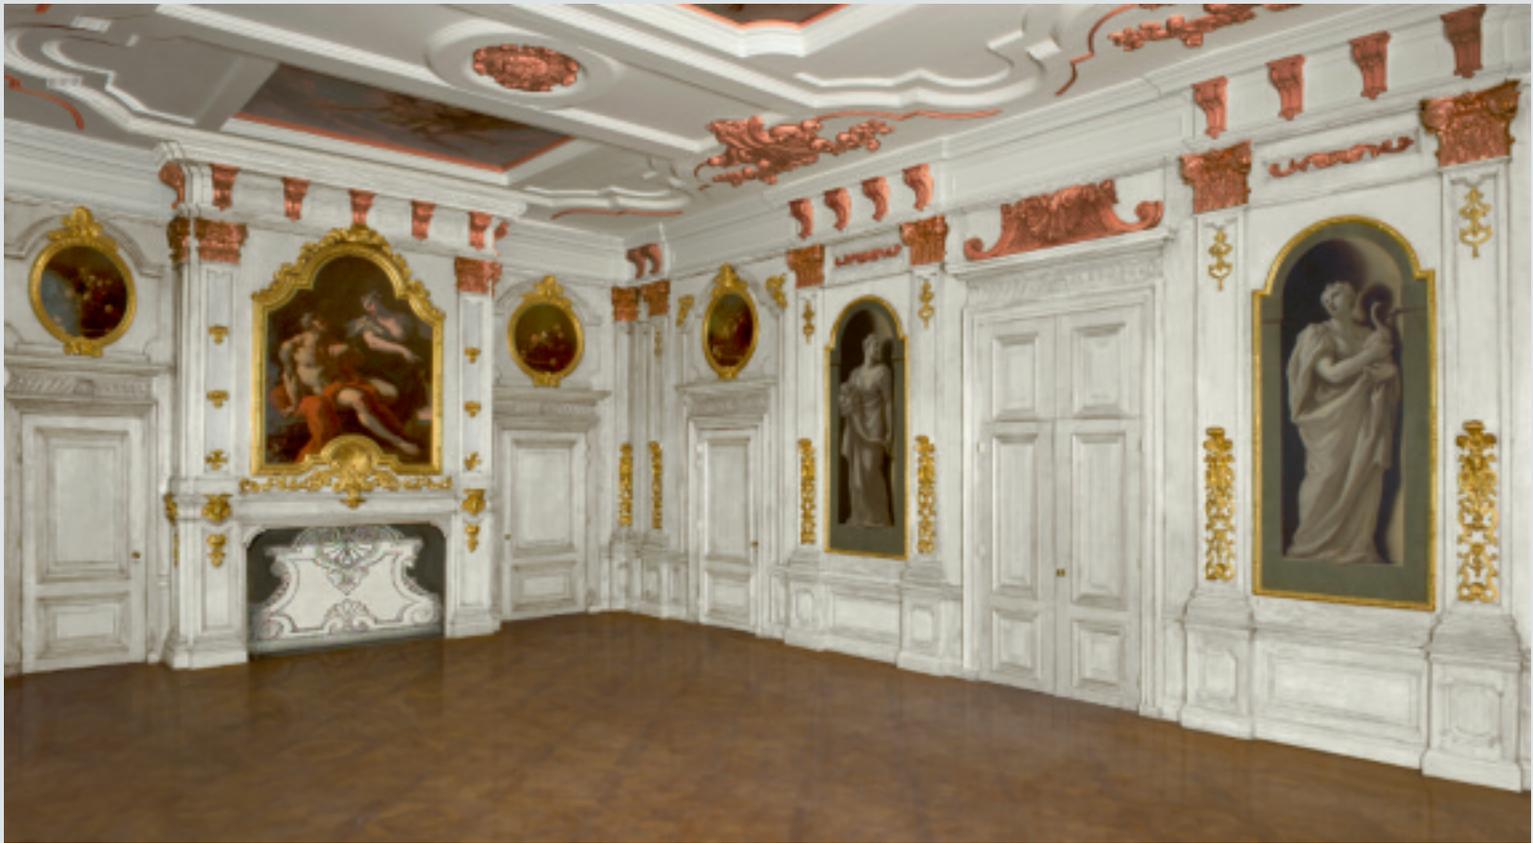
164 Digital impression of the original colour finish of the Golden Room. For the present situation, see fig. 126. Photo: Margareta Svensson. Digital manipulation: Lara de Moor, 2014.

It is not known why two types of metal were chosen. Copper is considerably less expensive than gold, and given that the money available for the renovation of the Mauritshuis was barely adequate, to put it mildly (see pp. 117-121), this might have been a consideration. This is supported by the fact that copper was used solely for decorations that were so high they could be seen only from a distance. Yet the choice could also have been made for aesthetic reasons. In the eighteenth century, gold and copper, like bronze, brass and silver, were often combined in decorations.²⁰ Differences in the way the metal leaf was polished resulted in varying degrees of shine. This, in combination with the use (or omission) of layers of varnish or glaze could produce numerous subtle gradations.²¹ In this large salon, which was illuminated in the evening by candlelight, the many copper and gold elements must have produced a spectacular effect (fig. 164).

tions on the pilasters, but otherwise it was mainly copper that shone in the ground-floor salon (fig. 164) – even in many places that are now stripped or painted white.
